Philips Healthcare

FSN-2021-CC-EC-012

TGA Reference #:	RC-2022-RN-00499-1
Product / Device Name / Model #	Philips M5071A (adult) and M5072A (infant/child) for use specifically with the HeartStart HS1 AEDs/OnSite/Home AED
ARTG Ref #	337264, 374814
Short Problem Description	Adult SMART Pads Cartridge and the Infant/Child SMART Pads Cartridge for use with HS1/OnSite/Home AEDs may experience gel separation and reduction of gel surface area

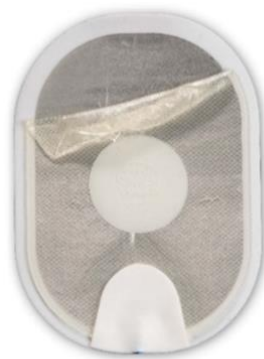
2. Describe the hazard/harm associated with the issue	<p>When a pad with separated, folded gel is placed on the patient's bare skin, the HS1/OnSite/Home AED could deliver less effective or ineffective therapy to the patient due to the reduced surface contact area with the skin. See example picture in Figure 1.</p> <p>Separated, folded gel may also have a discolored and/or melted appearance. While the gel may also have a discolored and/or melted appearance, the appearance does not have any impact on the delivery of therapy; however, there may be a delay in therapy if the user hesitates to apply the pad due to its appearance, and the AED may deliver less effective or ineffective therapy to the patient due to the reduced contact area with the skin. See example picture in Figure 2.</p> <p>It is also possible that the gel could separate almost completely from the foam/tin backing when peeled, (see Figure 3.) Due to a small amount of gel surface contact area with the skin, electrical arcing could occur when a shock is delivered leading to burns to the patient's skin, or the AED could be unable to deliver any shock through the pads. A delay in therapy will result while the user installs a replacement pads cartridge (if available) or performs CPR while waiting for Emergency Medical Services Personnel to arrive. For comparison, Figure 4 shows a normal pad. No matter the state of the pad, follow the voice prompts because the AED will step you through the necessary actions.</p> <p style="text-align: center;"><i>(continued to next page)</i></p>

Figure 1: Separated gel that has folded onto itself when peeled.

Action:
Apply pads to the patient.
Do not hesitate.

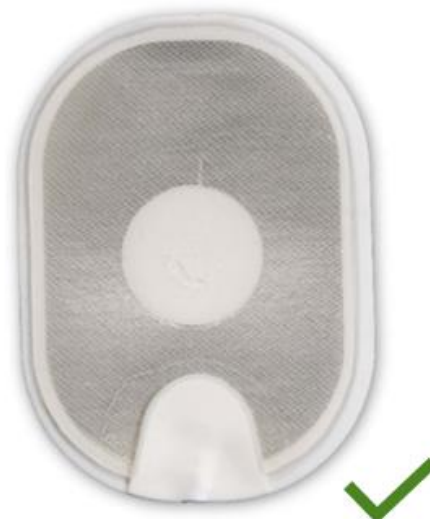
Figure 4: Normal pad.

Action:
Apply pads to the patient according to the Instructions for Use/Owner's Manual.
