URGENT Medical Device Correction

M5071A (adult) and M5072A (infant/child) pads for use with HS1/OnSite/Home AEDs may experience gel separation and reduction of gel surface area

14-FEB-2022

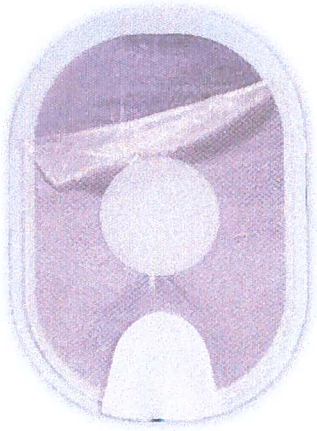
When a pad with separated, folded gel is placed on the patient's bare skin, the HS1/OnSite/Home AED could deliver less effective or ineffective therapy to the patient due to the reduced surface contact area with the skin. See example picture in **Figure 1**.

***Figure 1**: Separated gel that has folded onto itself when peeled.*

Action:
Apply pads to the patient.
Do not hesitate.

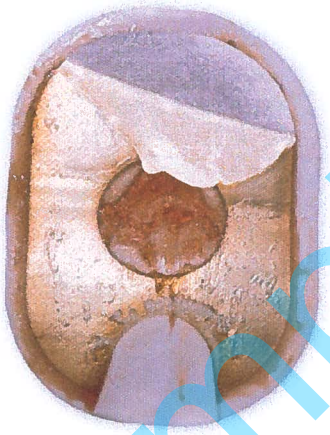
Separated, folded gel may also have a discolored and/or melted appearance. While the gel may also have a discolored and/or melted appearance, the appearance does not have any impact on the delivery of therapy;

however, there may be a delay in therapy if the user hesitates to apply the pad due to its appearance, and the AED may deliver less effective or ineffective therapy to the patient due to the reduced contact area with the skin. See example picture in **Figure 2**.

***Figure 2**: Separated, folded gel may also have a discolored and/or melted appearance.*

Action:
Apply pads to the patient.
Do not hesitate.

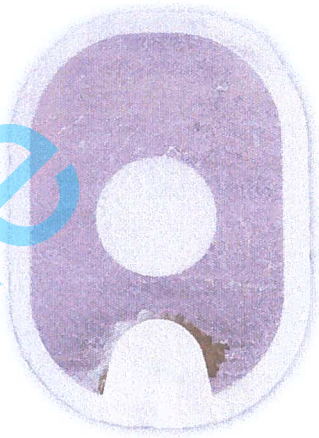
It is also possible that the gel could separate almost completely from the foam/tin backing when peeled, (see **Figure 3**.) Due to a small amount of gel surface contact area with the skin, electrical arcing could occur when a shock is delivered leading to burns to the patient's skin, or the AED could be unable to deliver any shock through the pads. A delay in therapy will result while the user installs a replacement pads cartridge (if available) or performs CPR while waiting for Emergency Medical Services Personnel to arrive. For comparison, **Figure 4** shows a normal pad. No matter the state of the pad, follow the voice prompts because the AED will step you through the necessary actions.

***Figure 3**: Gel almost completely separated from backing.*

Action:
Replace pads cartridge if a spare is available. If no spare is available, perform CPR until help arrives.
