## URGENT – Medical Device Recall

**Product:** Philips M5071A (adult) and M5072A (infant/child) AED pads  
**Date:** March 2, 2022  
**Subject:** M5071A (adult) and M5072A (infant/child) pads for use with HS1/OnSite/Home AEDs may experience gel separation and reduction of gel surface area

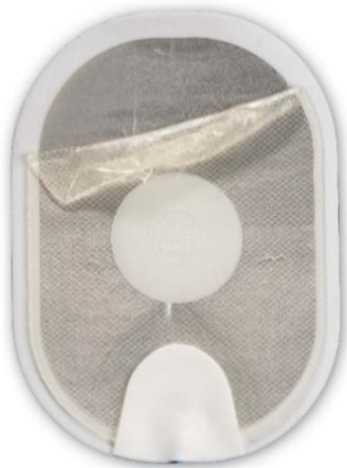
When a pad with separated, folded gel is placed on the patient's bare skin, the HS1/OnSite/Home AED could deliver less effective or ineffective therapy to the patient due to the reduced surface contact area with the skin. See example picture in **Figure 1**.

**Figure 1:** Separated gel that has folded onto itself when peeled.

*Action:*  
Apply pads to the patient.  
Do not hesitate.

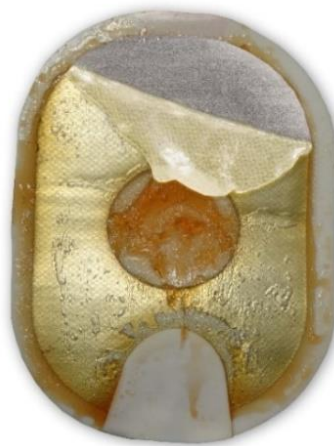
Separated, folded gel may also have a discolored and/or melted appearance. While the gel may also have a discolored and/or melted appearance, the appearance does not have any impact on the delivery of therapy; however, there may be a delay in therapy if the user hesitates to apply the pad due to its appearance, and the AED may deliver less effective or ineffective therapy to the patient due to the reduced contact area with the skin. See example picture in **Figure 2**.

**Figure 2:** Separated, folded gel may also have a discolored and/or melted appearance.

*Action:*  
Apply pads to the patient.  
Do not hesitate.

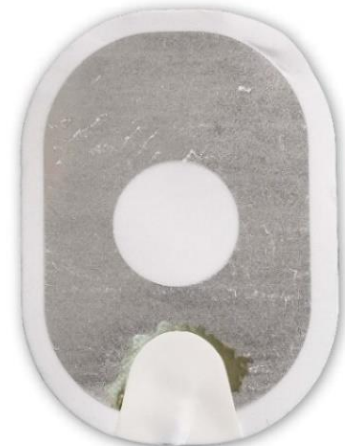
It is also possible that the gel could separate almost completely from the foam/tin backing when peeled, (see **Figure 3**.) Due to a small amount of gel surface contact area with the skin, electrical arcing could occur when a shock is delivered leading to burns to the patient's skin, or the AED could be unable to deliver any shock through the pads. A delay in therapy will result while the user installs a replacement pads cartridge (if available) or performs CPR while waiting for Emergency Medical Services Personnel to arrive. For comparison, **Figure 4** shows a normal pad. No matter the state of the pad, follow the voice prompts because the AED will step you through the necessary actions.

**Figure 3:** Gel almost completely separated from backing.

*Action:*  
Replace pads cartridge if a spare is available. If no spare is available, perform CPR until help arrives.

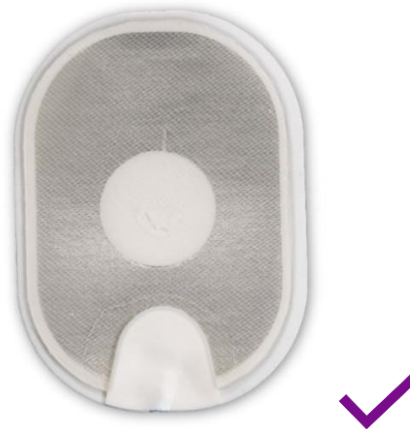
**Figure 4:** Normal pad.

*Action:*  
Apply pads to the patient according to the Instructions for Use/Owner's Manual.
